REVISED ANADROMOUS STREAM CATALOG OF SOUTHEASTERN ALASKA

District 106

Northeast Coast of Prince of Wales Island

Subdistricts 106-30 and 106-10

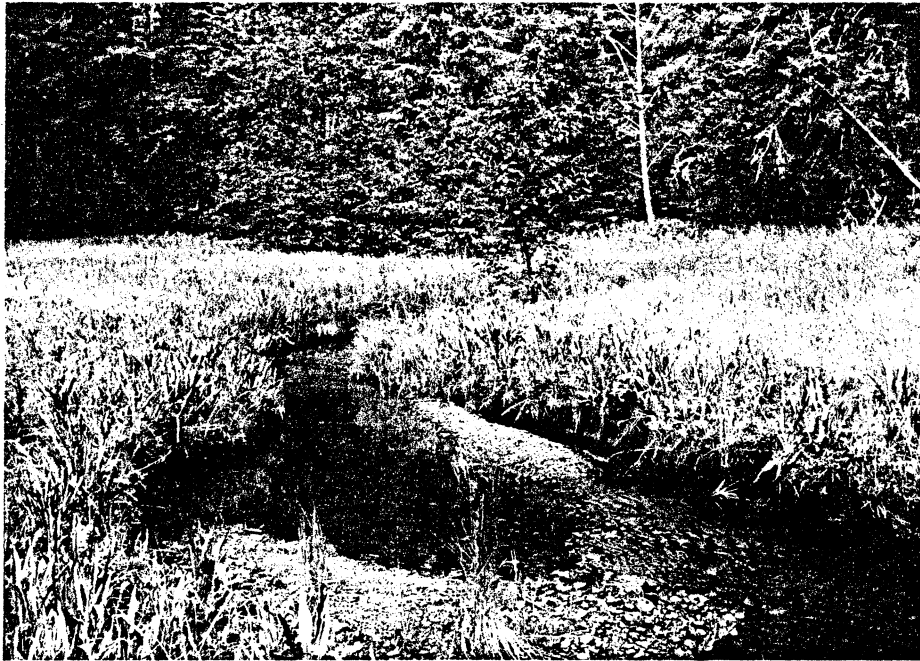
West Exchange Cove #5

1. The ITZ looking toward the creek mouth. Intertidal ASA is limited due to sandy substrate.

The ITZ of this small stream merges with the ITZ of West Exchange Cove #4 and Exchange Creek. The exclusive ITZ for this stream cuts a sinuous channel through the grass flat. Intertidal ASA is limited by sandy substrate. Fish habitat is good near the mouth, but steadily deteriorates moving upstream. Two spur roads have been constructed on either side of the stream to access a future timber harvest. Substantial buffer strips should be left along both banks to protect this temperature sensitive stream.

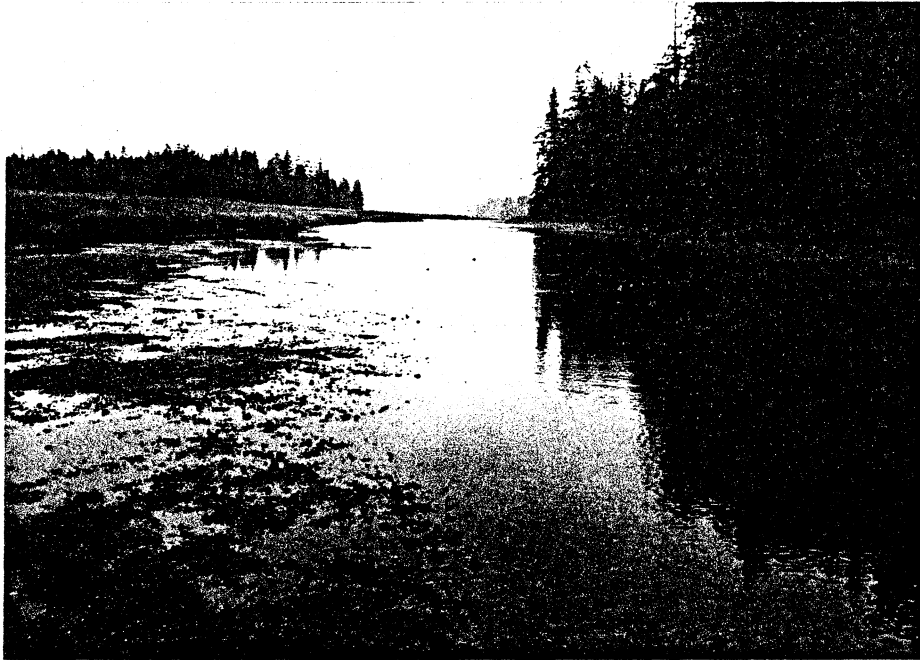
1. The ITZ looking downstream from Section 11.

Survey Areas A & B were surveyed in June; Areas C & D were surveyed in September. By September PS had entered the system and were found in Survey Areas C & D. Exchange Creek is a known pink and chum salmon stream. Coho fry were found in all survey areas with the possible exception of Survey Area D. Fish habitat is variable throughout Exchange Creek but generally good.

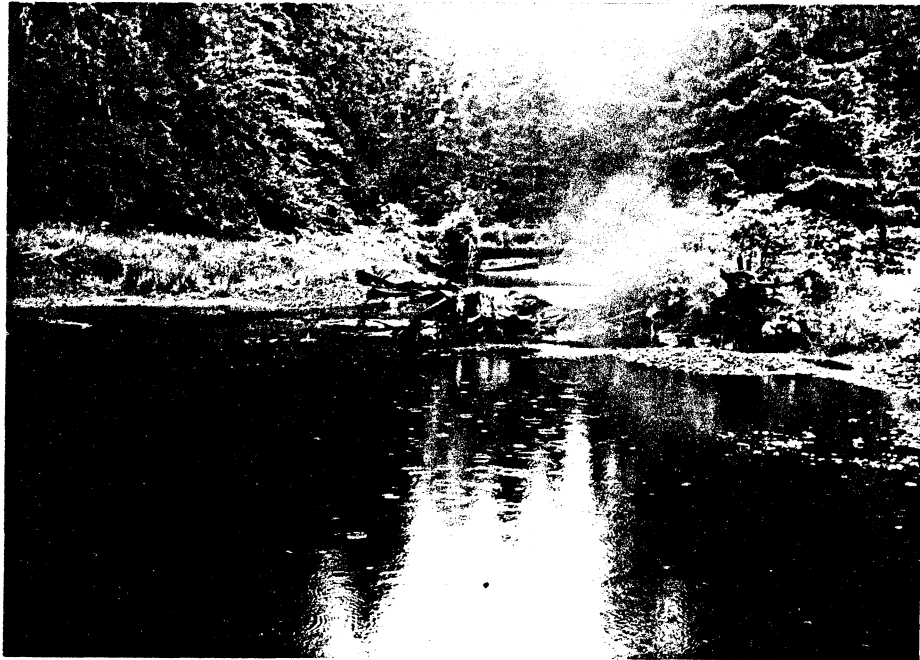
2. Section 3I looking at the creek mouth.

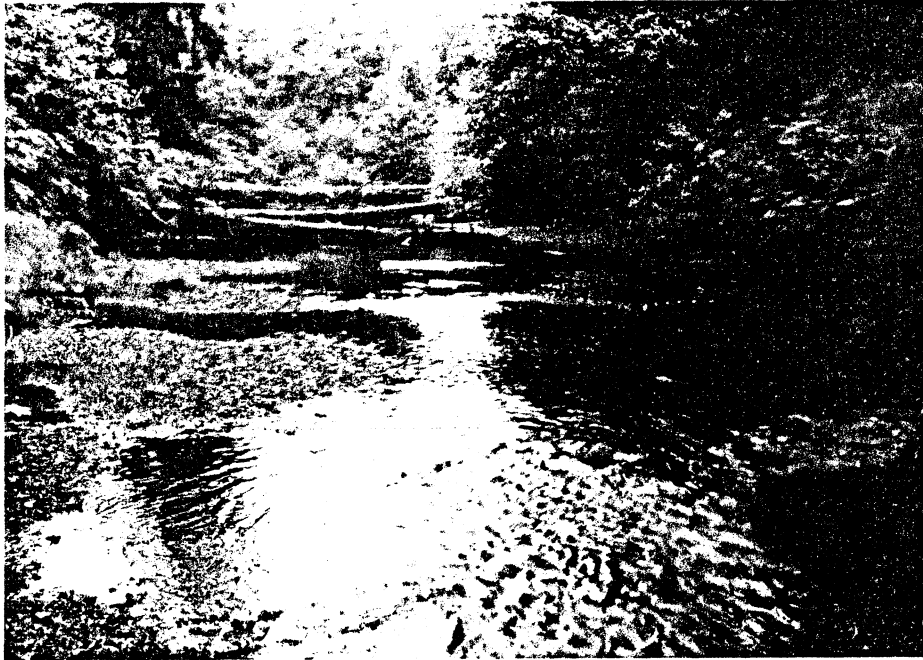
Exchange Creek

3. A shallow, wide channel with massive blowdown in the background of Section 4.

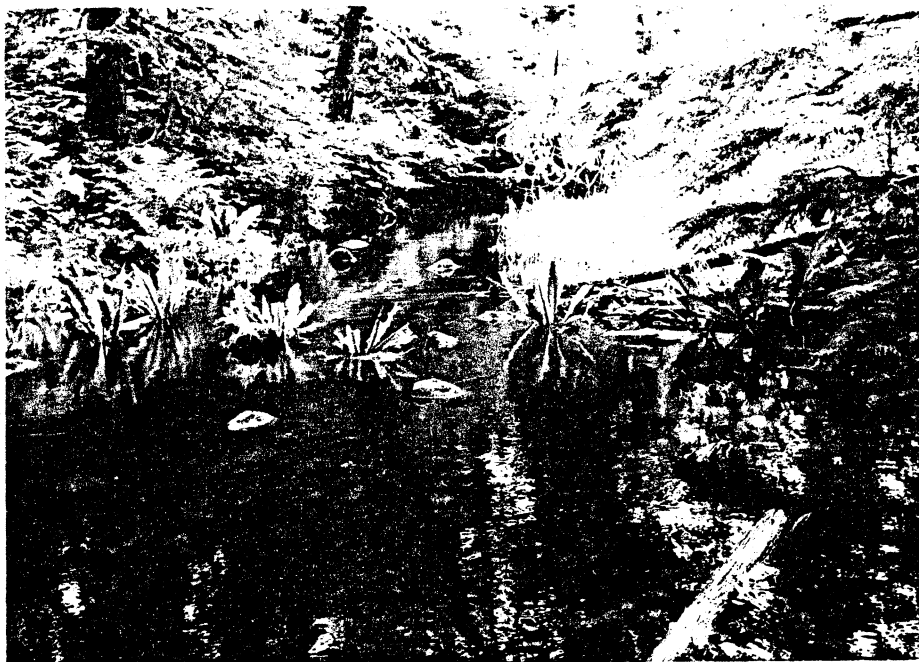
Exchange Creek

7. The flow resumes in Section 10. Mid channel skunk cabbage indicates stable flow.

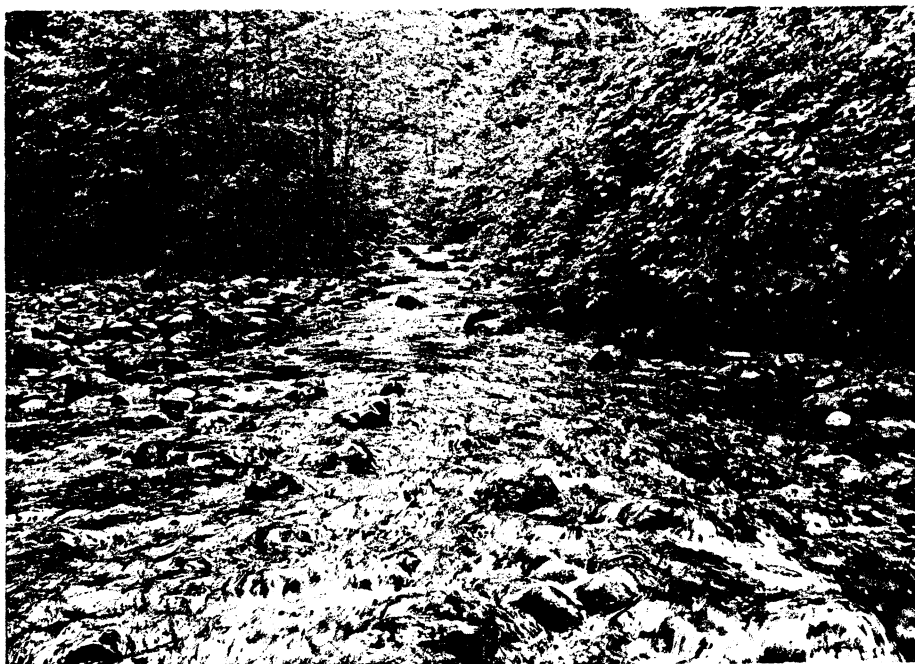
8. Mouth of Survey Area "B".

This survey area enters the right bank at the end of Section 7; Survey Area A. This tributary becomes steep with large cobble/boulder substrate soon after the confluence with Survey Area A. Fish habitat deteriorates steadily until Section 5. At this point gradient becomes low/moderate with smaller substrate. ASA and rearing habitat are good until an abrupt gradient increase in Section 10. Blue clay deposits are common along the banks in Sections 7-10.

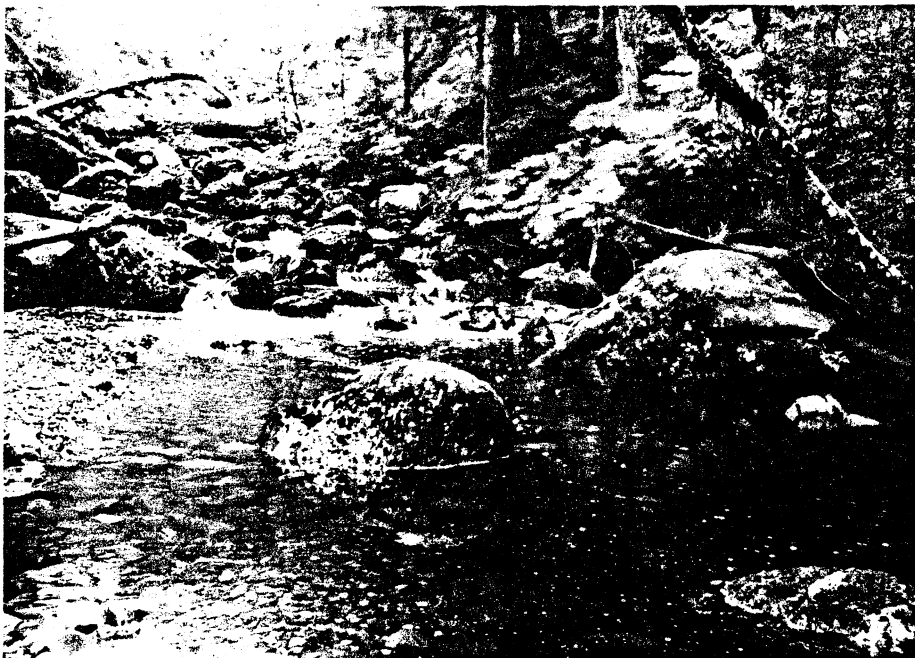
Exchange Creek
Survey Area "B"

9. Large boulders and bedrock dominate the substrate in Section 3.

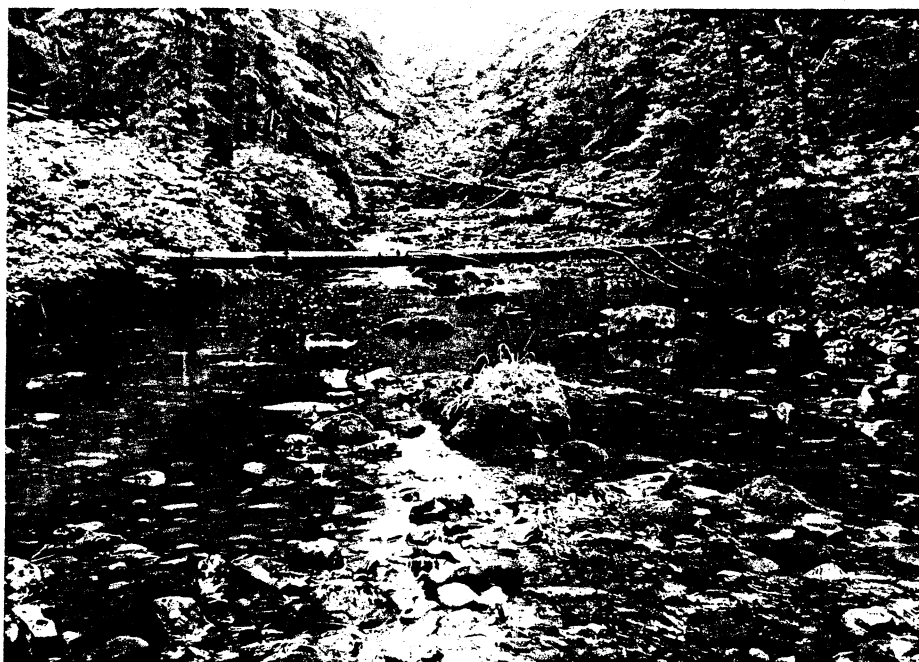
10. Gradient becomes moderate in Section 5. ASA and rearing habitat improve.

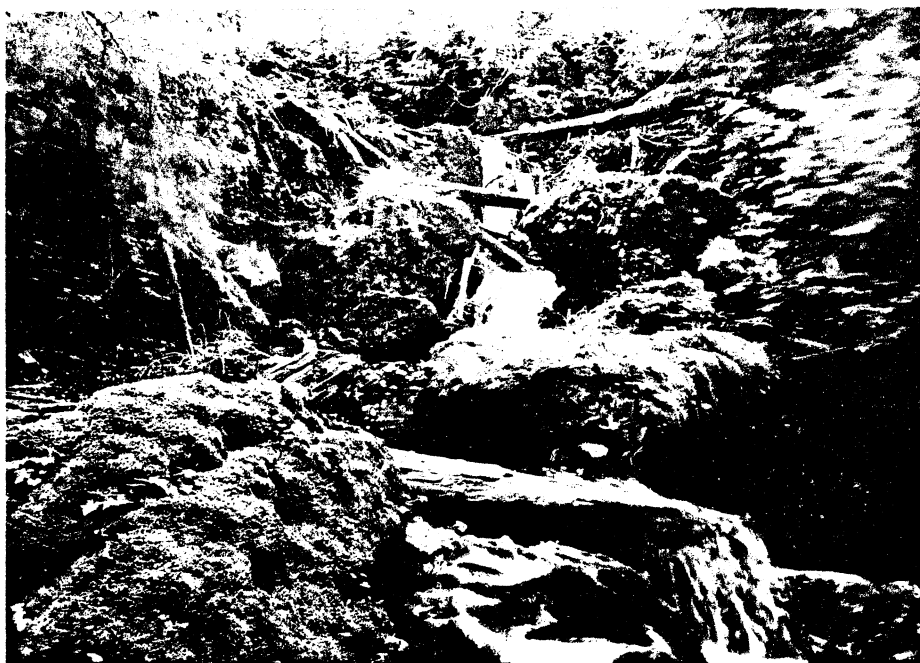
12. This survey terminates at a 2 m barrier falls (background) at the end of Section 11.

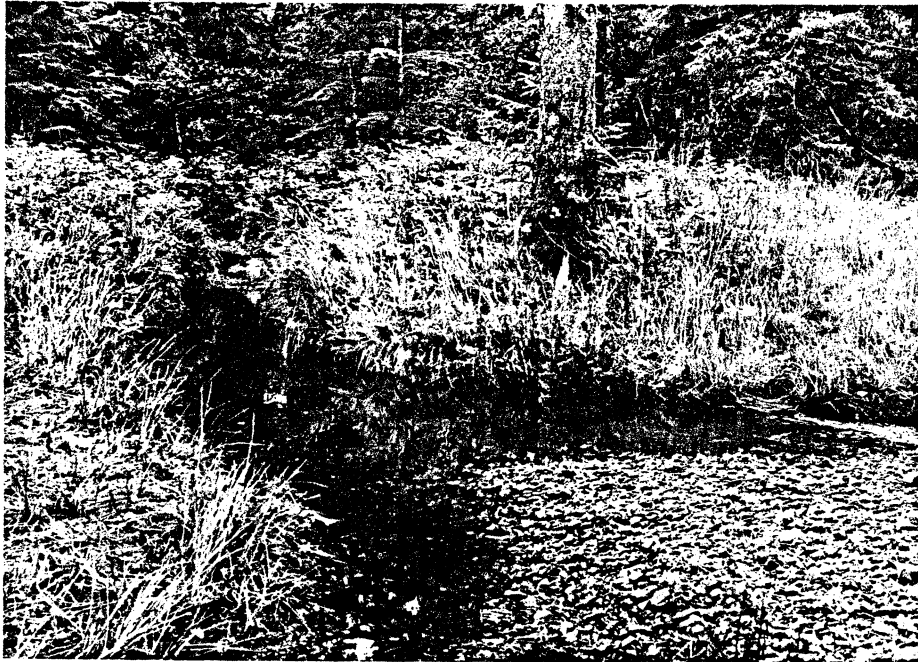
Exchange Creek
Survey Area "C"

13. Confluence with Exchange Lake. Twelve pink salmon carcasses were observed along the banks near the mouth.

The Southwestern headwater drainage to Exchange Lake is a small, sinuous stream which meanders through sumpy lowlands, providing 300 meters of excellent spawning and rearing habitat. An abrupt change in habitat (i.e., Reach 2), characterized by reduced channel width, increased gradient, and coarse substrate negated additional surveying due to a paucity of habitat. Rearing silver salmon fry were observed throughout Reach 1. No rehabilitation or enhancement recommended.

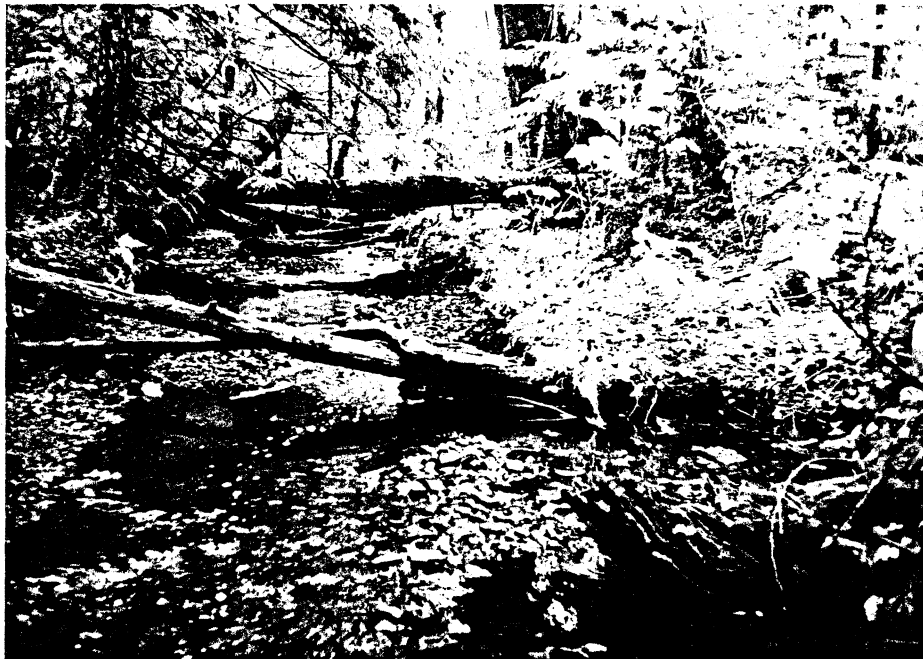
14. Section 1: Channel adopts a sinuous course through sumpy lowlands. Gravel/cobble riffles provide excellent spawning substrate.

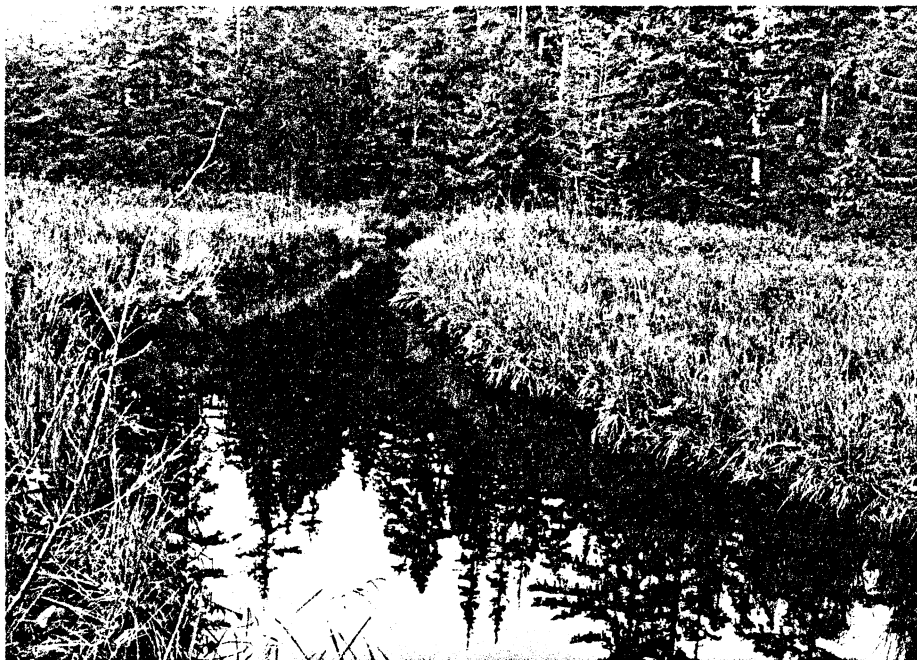
Exchange Creek
Survey Area "D"

15. Mouth of survey area, north headwater to Exchange Lake.

The Northern headwater of Exchange Lake is a small stream with good spawning and rearing habitat. Initially the stream flows through a grass meadow before entering forest cover. A full canopy along with considerable length of undercut banks provides good rearing cover though no fry were observed. Spawning gravel is patchy but of good quality. Substrate size increases during Section 3 and at Section 3: 100 m. The survey is terminated as the substrate composition becomes boulder/large cobble.

The banks of the stream were littered with pink carcasses (about 60) along with (8) adult pinks sighted in the stream. Possible use by coho, chum and sockeye salmon is likely.

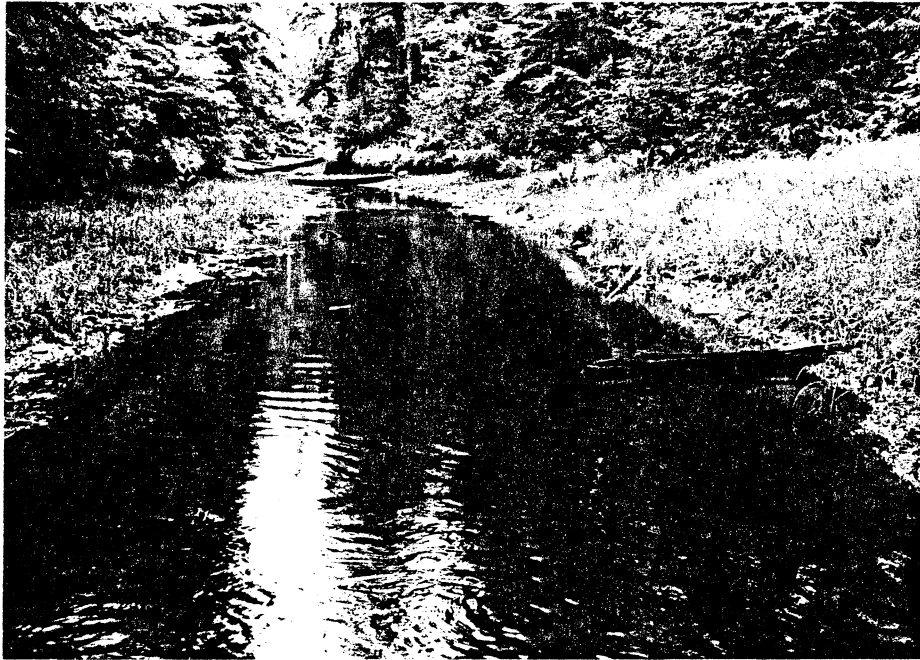
1. The intertidal substrate is composed almost entirely of sand and muck. Taken just below the ITZ confluence with Exchange Cove Head #2.

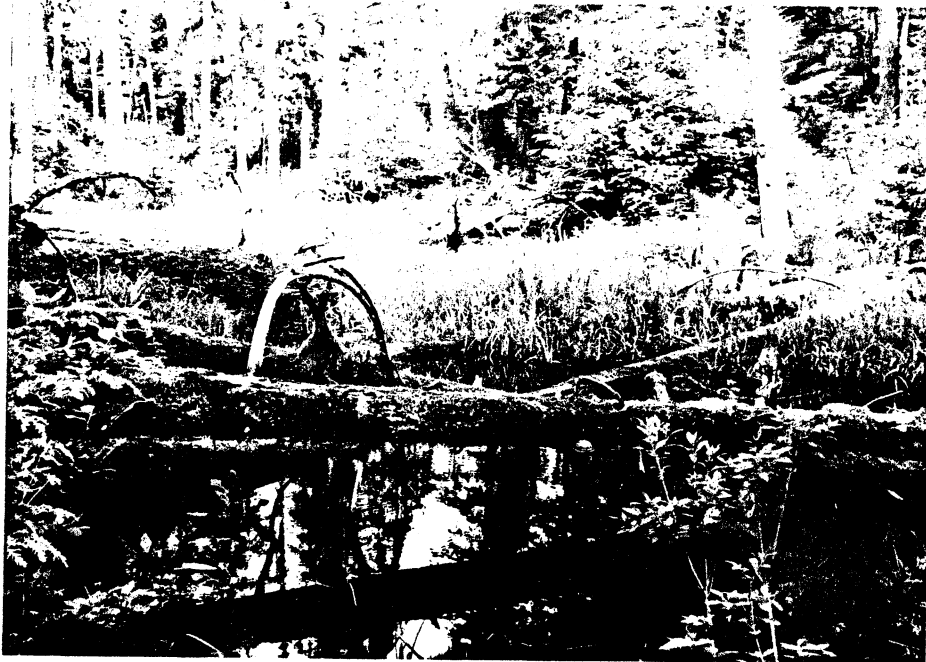
2. A large beaver system dominates the hydrology of the stream 65 m up from the ITZ.

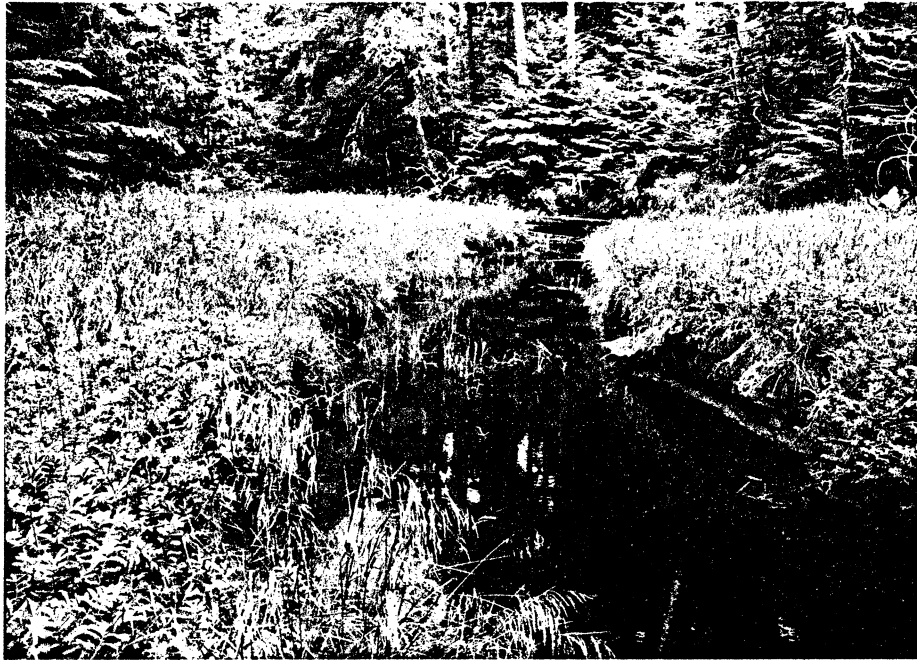
1. The ITZ looking downstream toward the confluence with Exchange Cove Head #1. Substrate is composed almost entirely of sand and muck.

The ITZ merges with the ITZ of Exchange Cove Head #1 (106-30-848). The intertidal substrate is composed almost entirely of sand and muck. The ITZ meanders 320 m up from the confluence providing excellent rearing habitat. The non-tidal portion of the stream is nearly indistinguishable from the ITZ for 50 m before a large beaver pond. The beaver system dominates 300 m of stream before returning to a rearing slough 350 m up to the logging road. Reconnaissance 200 m upstream of the road disclosed no change in habitat. No significant ASA was found in this stream although coho fry were common throughout the area surveyed.

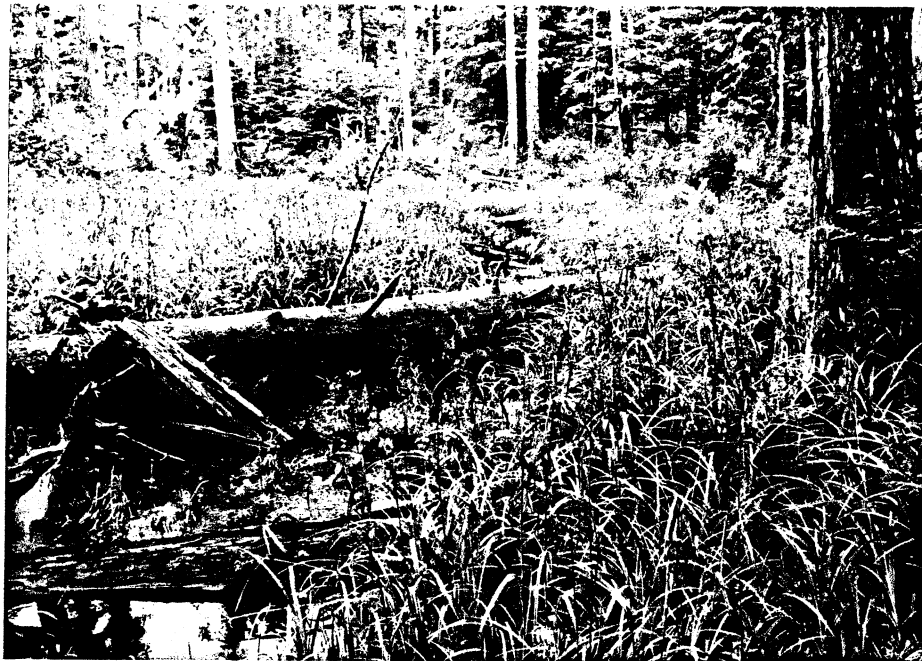
2. Rearing habitat is good in slough-like portion of stream above the beaver system.

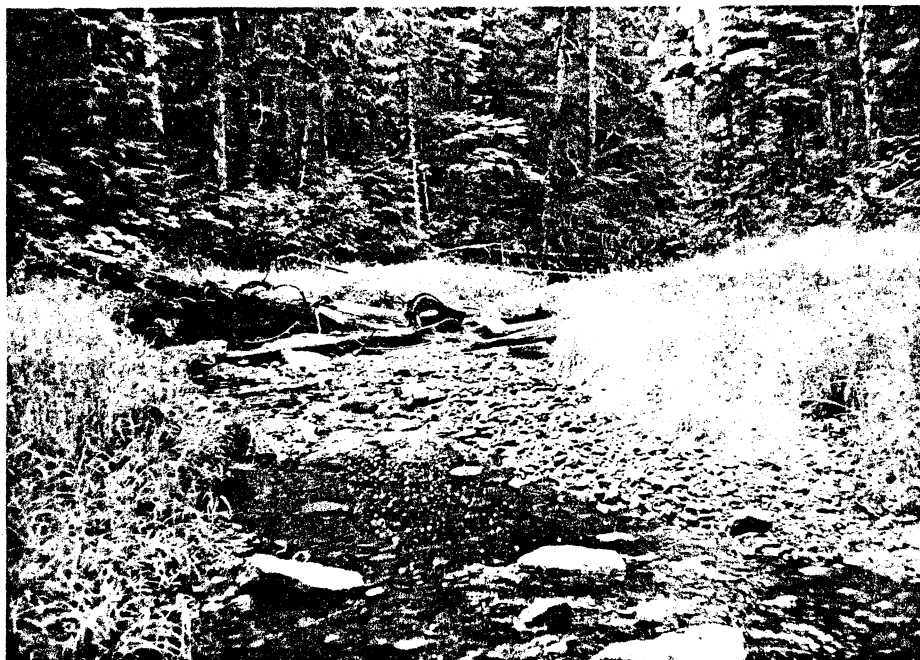
1. The bulk of available rearing and spawning habitat is concentrated near the mouth.

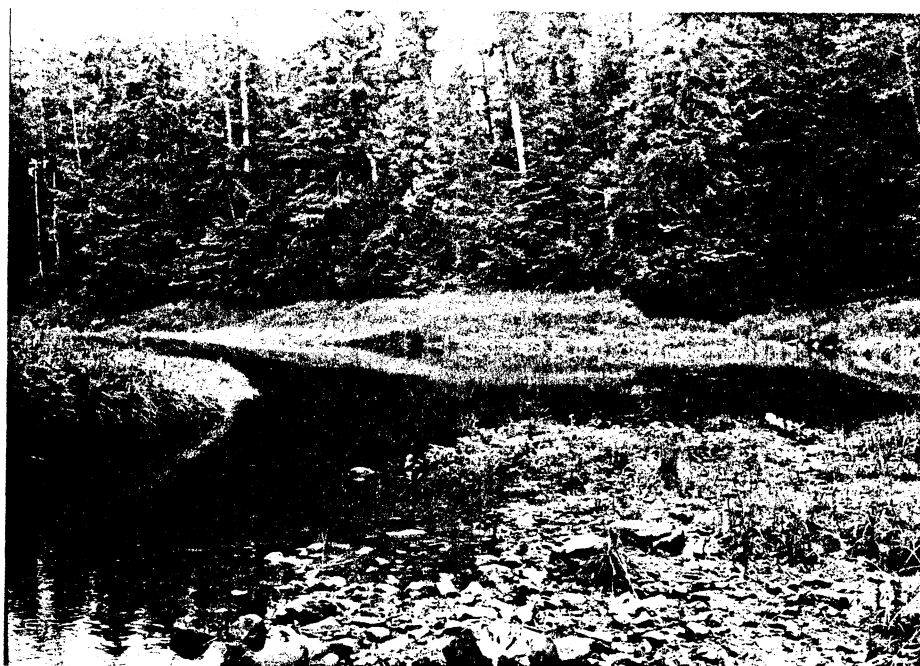
2. This moderately sized, muskeg influenced stream empties into the head of a tidal lagoon.

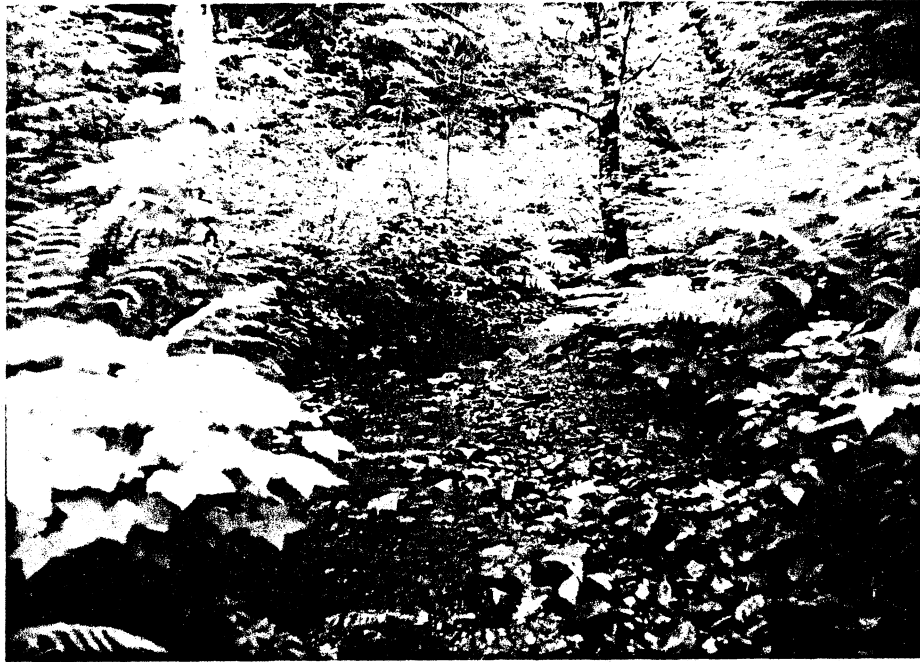
3. Increased channel sinuosity and bank undercutting, reduced gradient, extensive pooling, and muskeg seeps typify Reach 2.

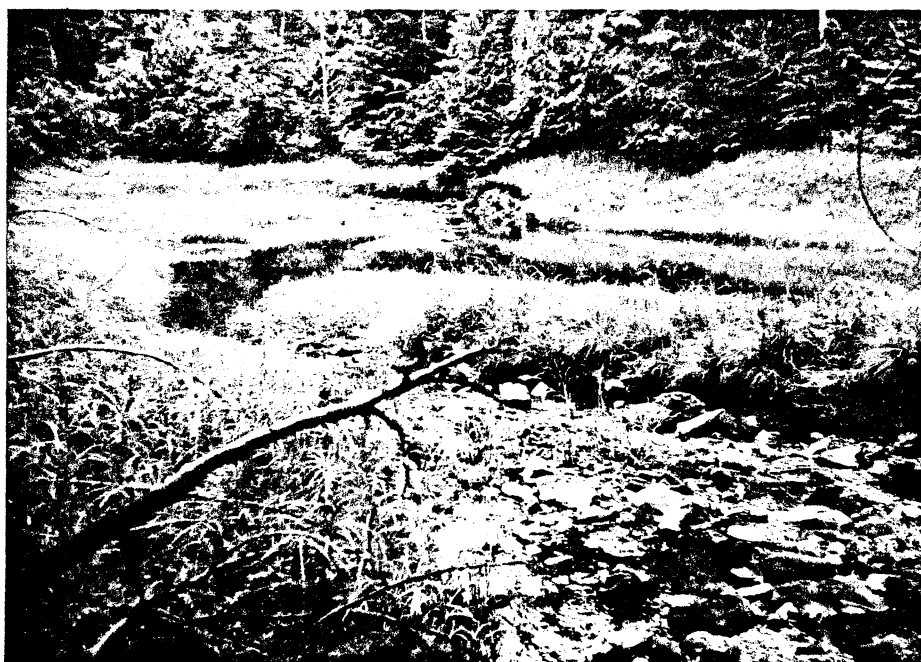
2. View down lower ITZ to a tidal lagoon and the mouth of Exchange Cove East #3.

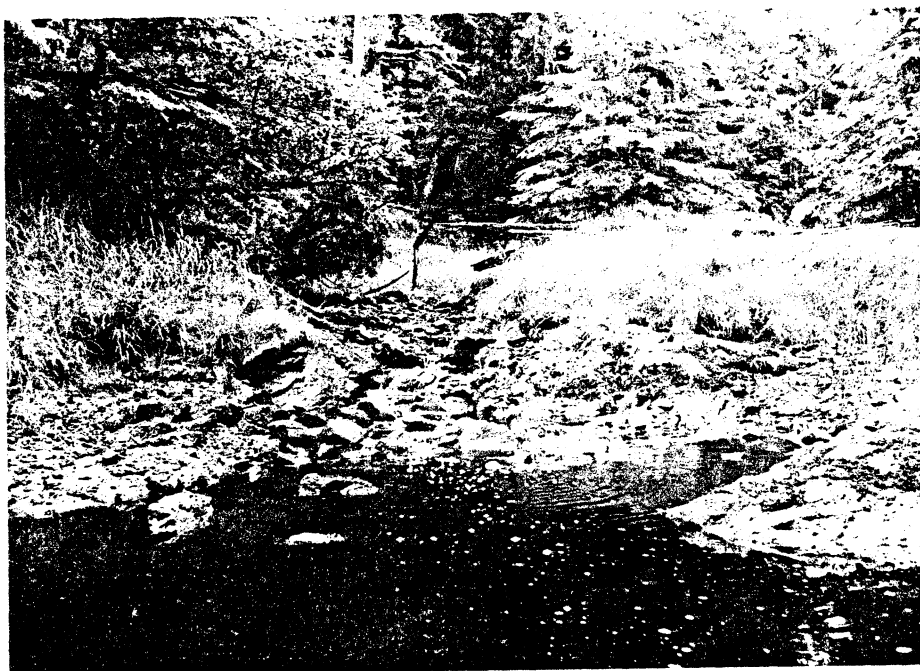
1. IT bedrock riffles drain this beaver/muskeg system.

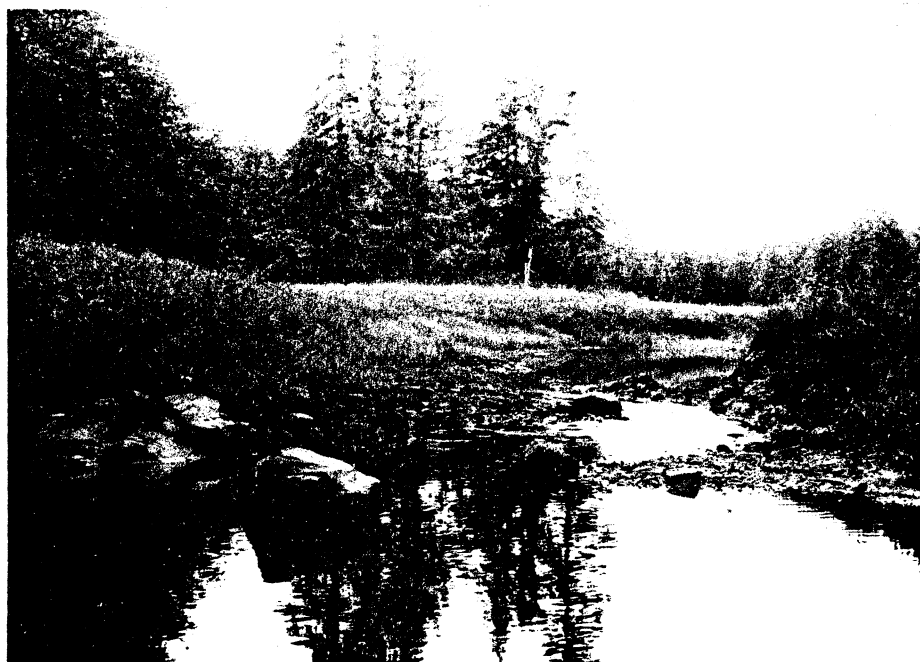
2. View down an extensive ITZ/marsh complex. Substrate was heavily silted and no fish or ASA was observed.

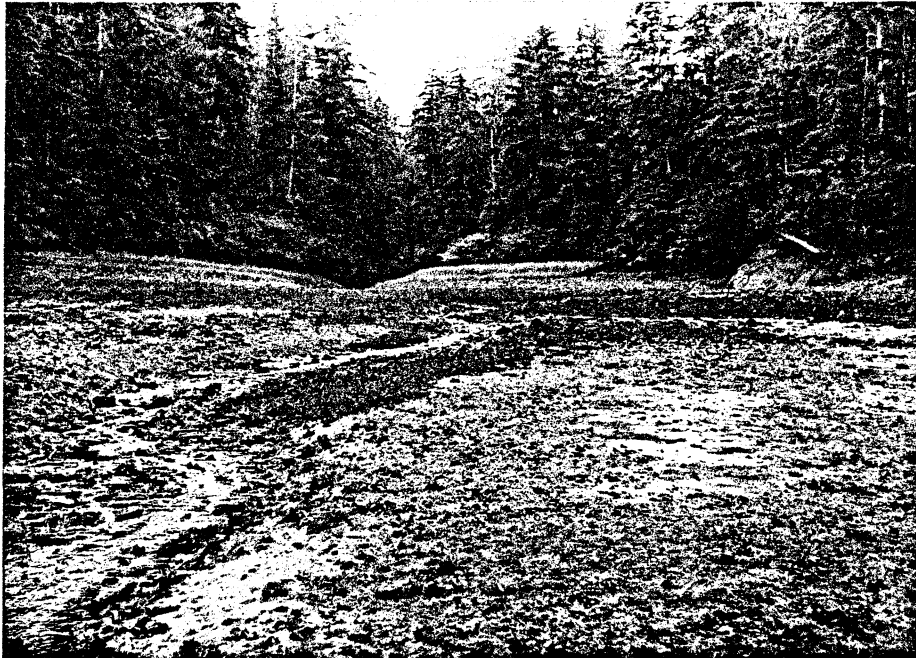
1. ITZ at low tide.

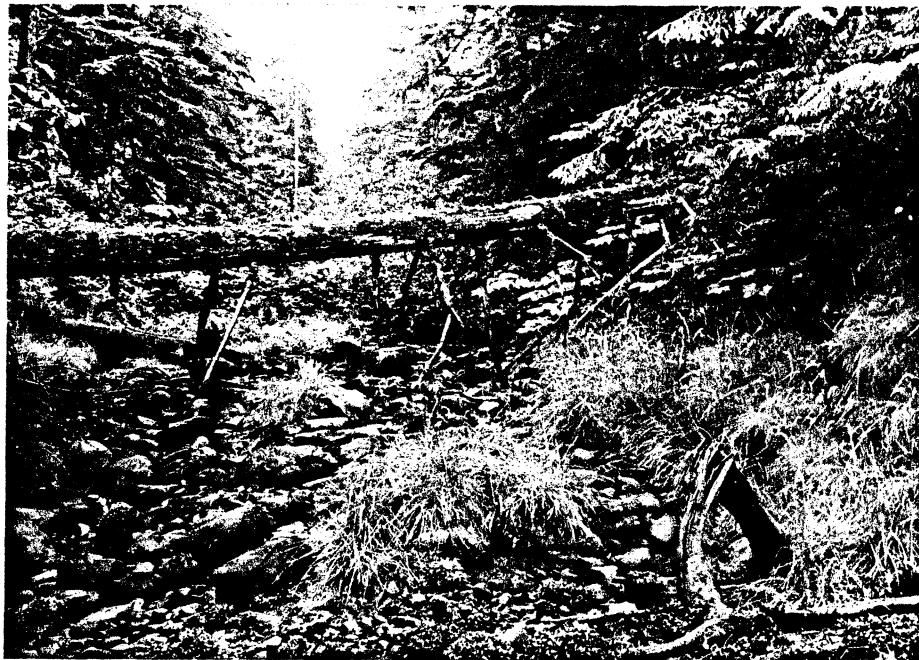
2. Mouth of stream with flow over boulder through V-notch.

A low productivity stream (only 1 DV fry sighted) that flows over boulder/cobble substrate between steep banks, and eventually up a V-notch. The stream has a steady 5% gradient up to two small lakes. No salmon fry were observed.

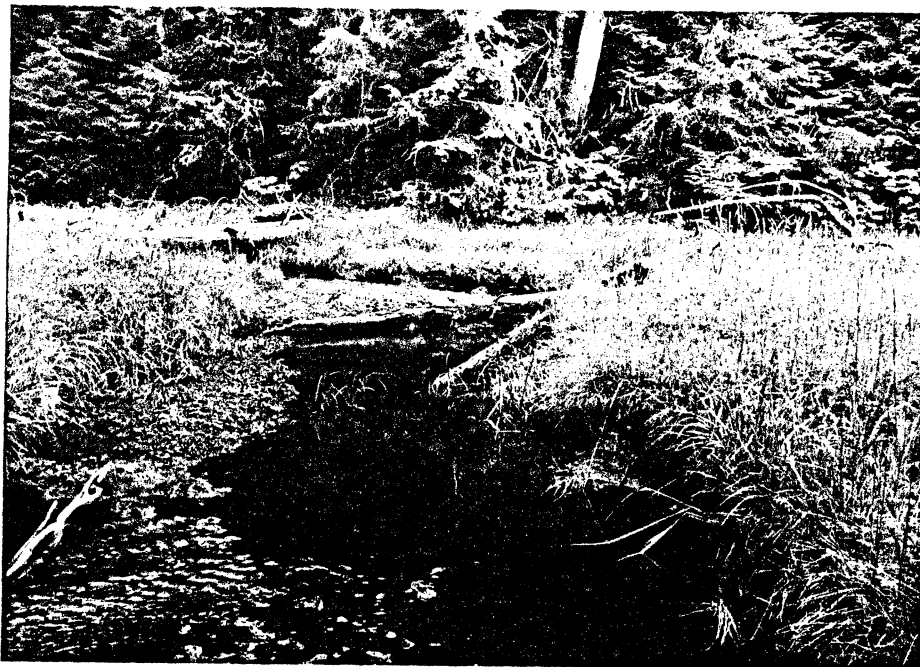
1. Upper ITZ rearing pools containing coho fry.

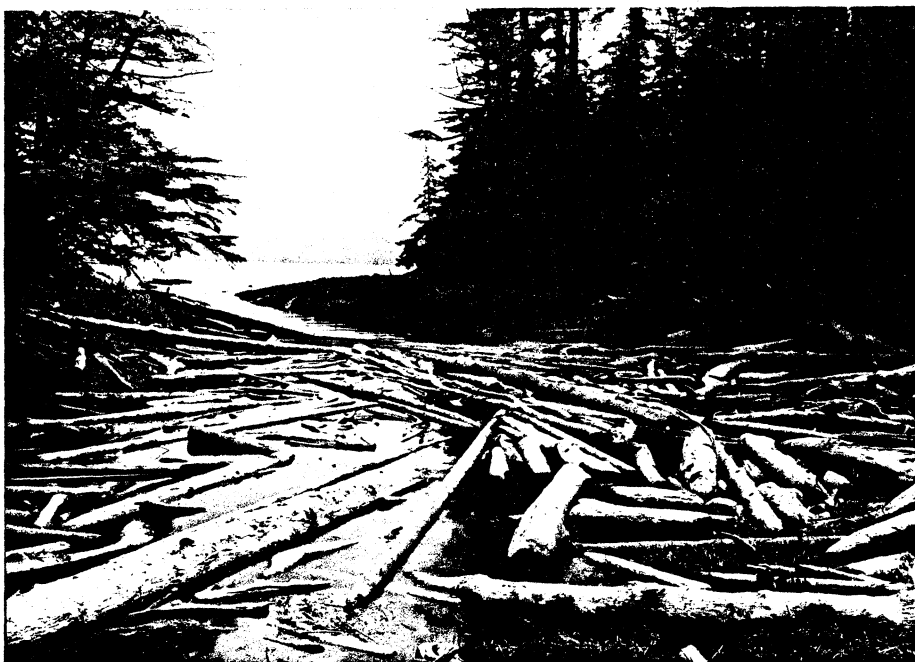
2. Downstream view of lower ITZ with beach debris.
Cove has open southeast exposure.

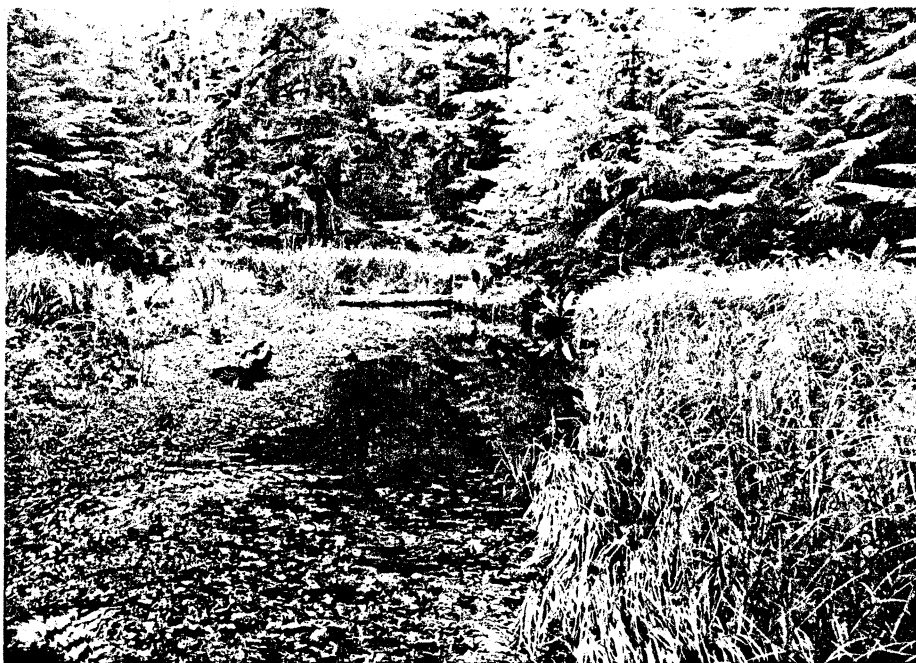
3. Mouth of stream with slow velocity flows.
Forbs in stream, right bank.

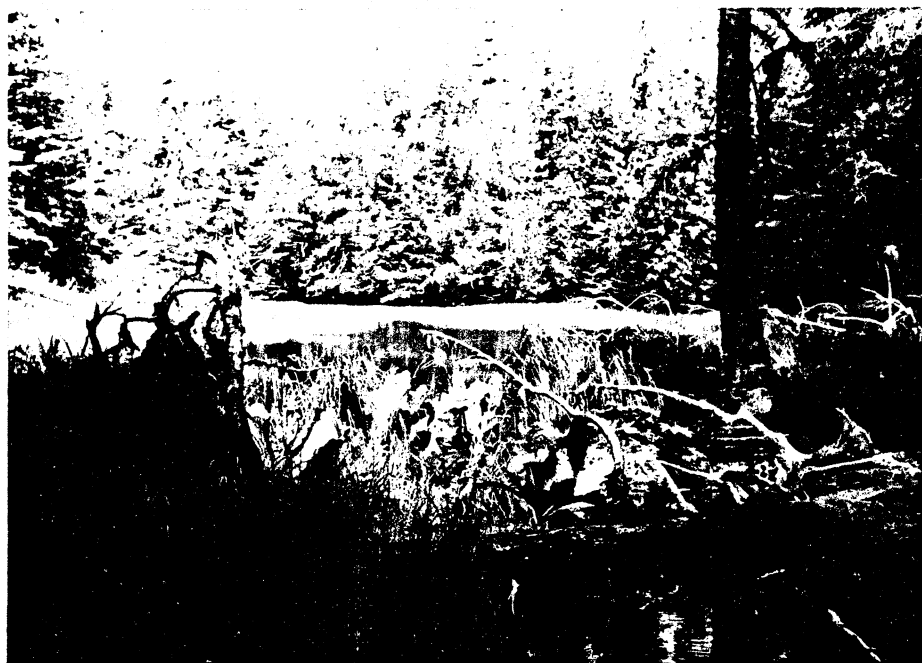
4 Overgrown beaver dam (1 x 30m) at
Section 10: 50m.

Section 10: 50m; Beaver dam (1 x 30m), old but in good repair. No active cutting. Deer sign noted.

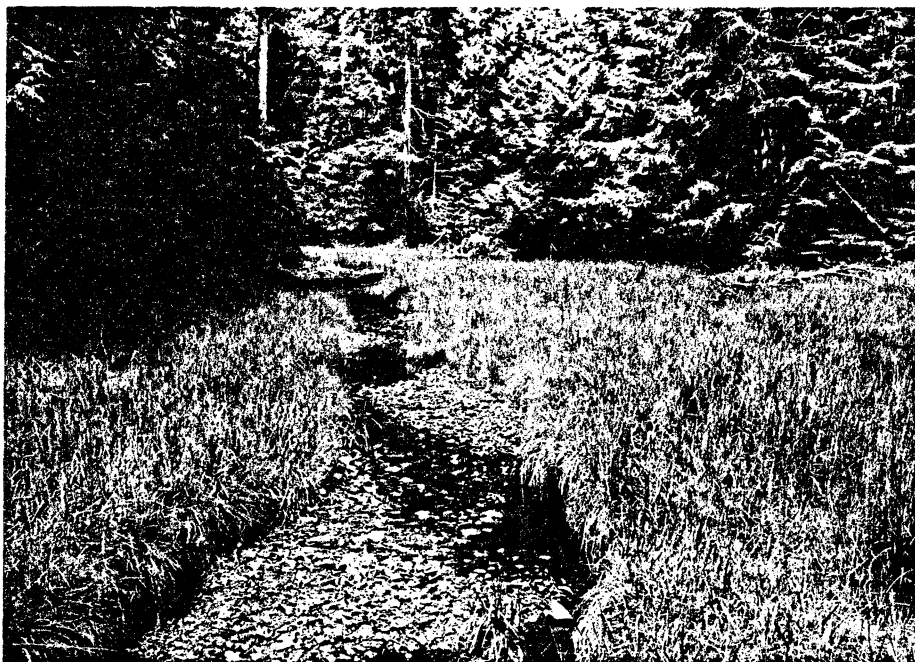
1. Upper intertidal rearing pools in grass meadow.

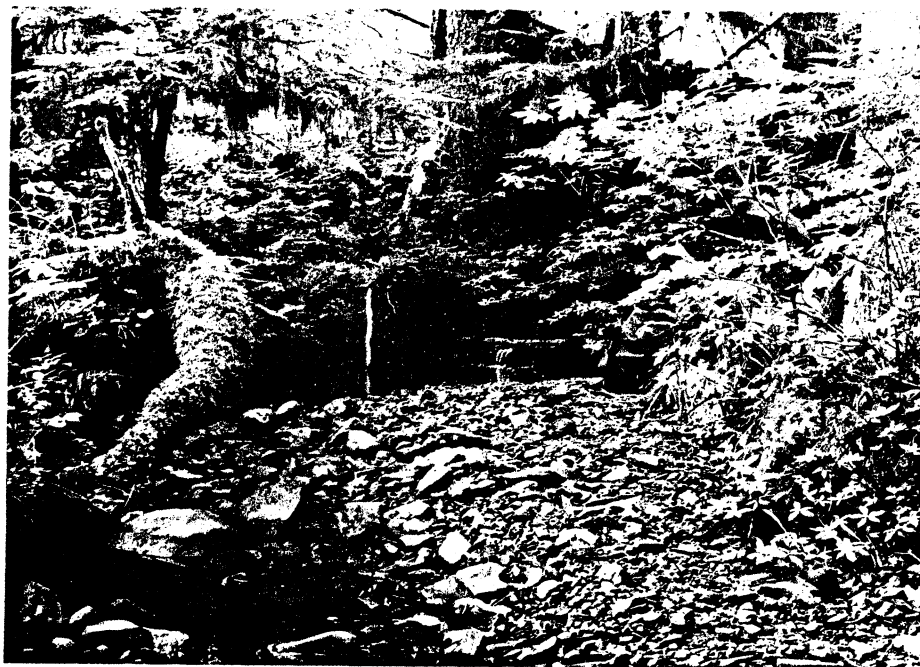
2. Mouth of stream with boulder/cobble substrate.

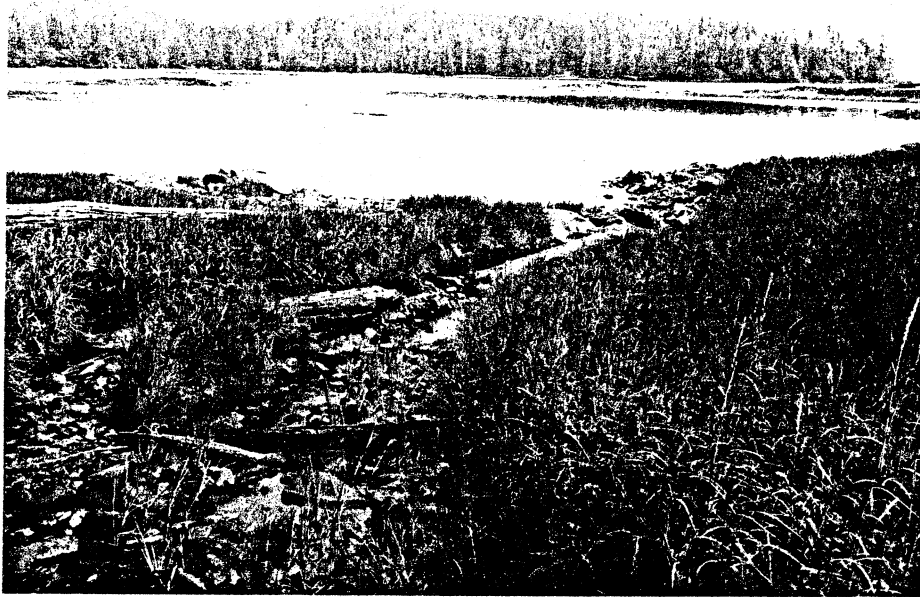
1. Downstream view of lower ITZ outlet from rearing pond.

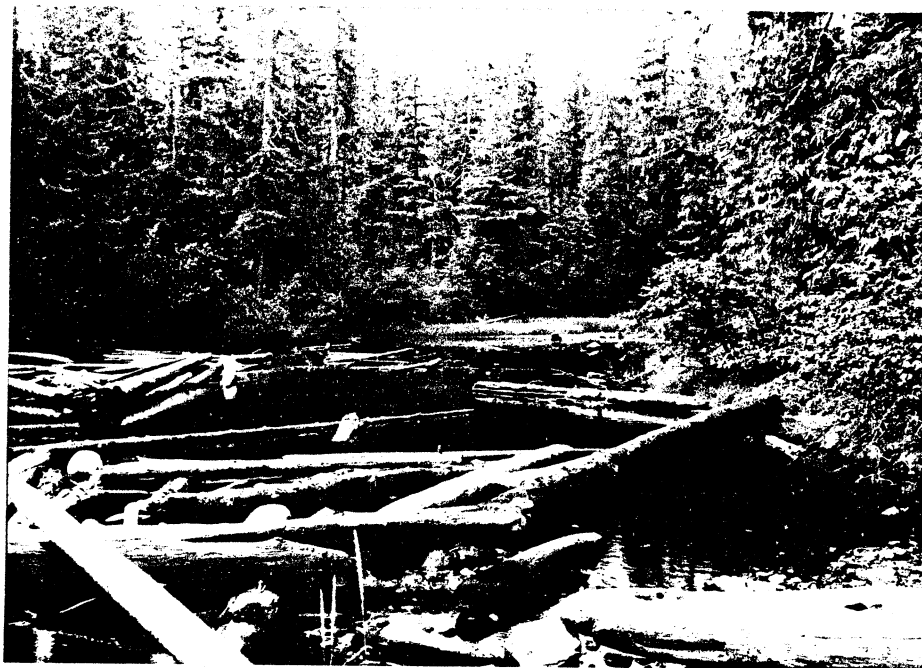
2. Intertidal rearing pond thick with coho fry.

This stream consists of a rearing slough through overhanging grass banks for 50 meters until going underground intermittently. The substrate is sand and gravel with the stream about 1 meter in width; heading 00°N at .5% gradient with no ASA. Many coho fry were observed in an intertidal rearing pond of the stream's ITZ.

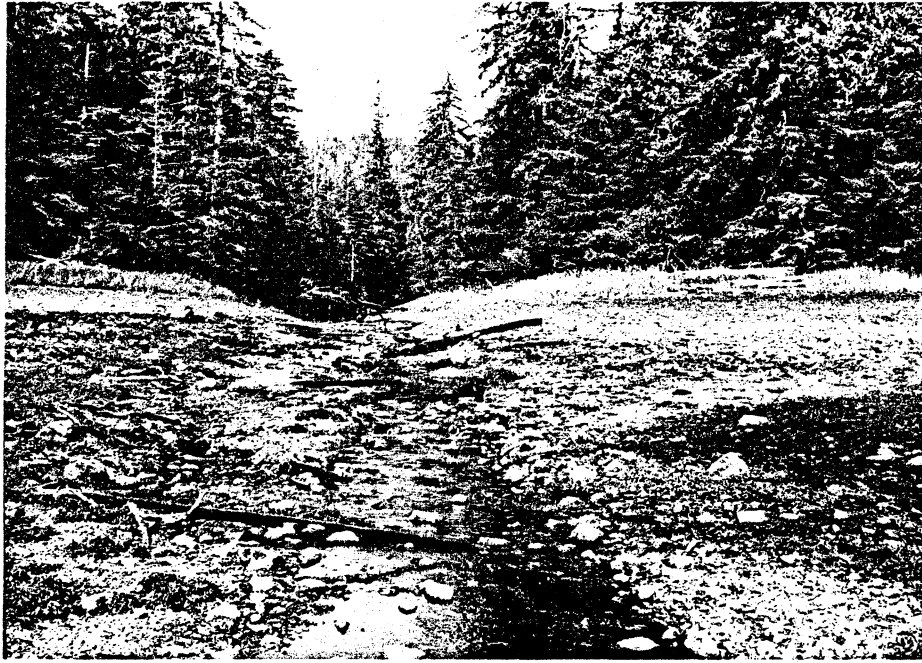
1. ITZ and mouth of Whale Pass #5.

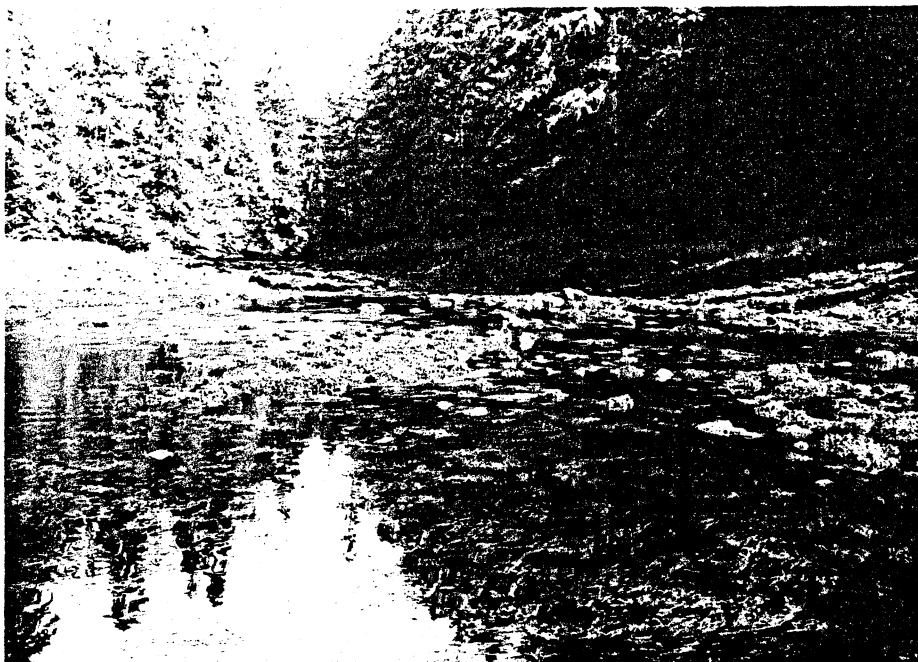
1. The ITZ looking at the stream mouth.

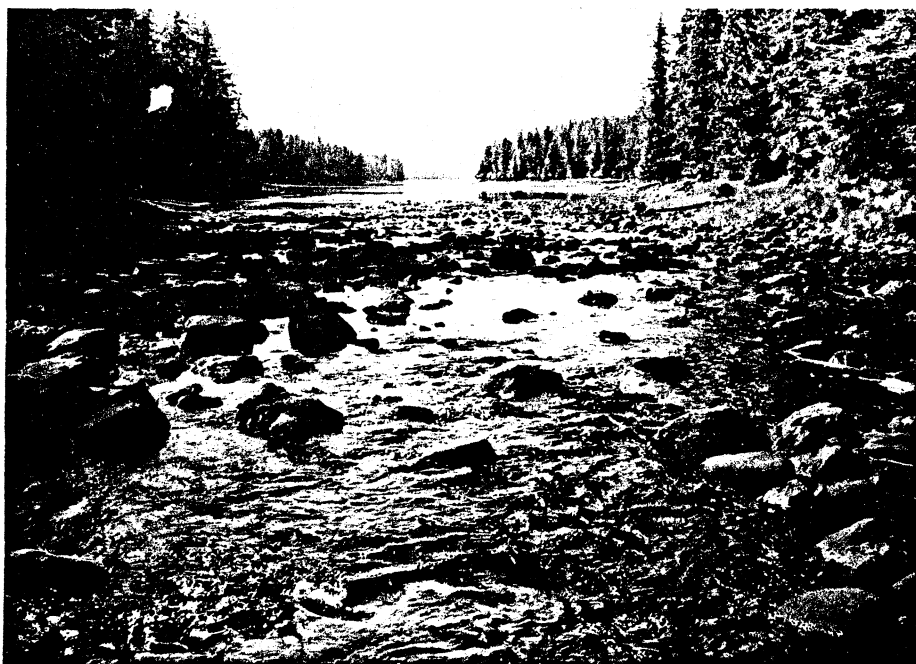
2. The ITZ looking downstream from the stream mouth.
